## APPENDIX 5 – BAT SURVEY RESULTS

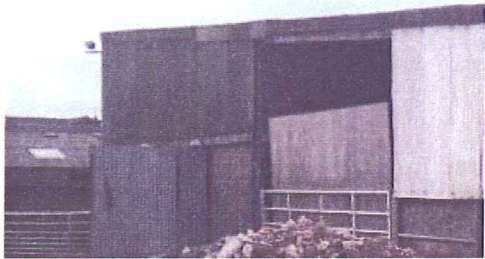
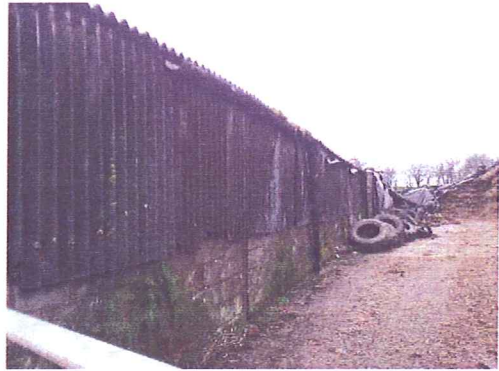
<p><b>Description:</b> Eastern (Photo A) and northern (Photo B) aspect have breeze block lower walls with corrugated sheets as upper part of side walls. Roof is slanted and built from corrugated plastic/metal with clear skylights present. Gap where walls meet the roof and gutter have large unsuitable gaps. Narrow crevice present under doorframe where sliding door sits – likely to be subjected to high disturbance levels and unsuitable for bats.</p> <p><b>Bat Roost Potential:</b> None.</p> <p><b>Key Results and Potential Roosting Sites:</b> No evidence of bats found at the time of the survey.</p>	
<p><b>Photo C:</b></p>

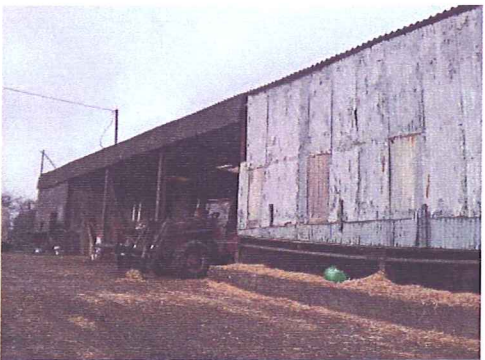
<p><b>Description:</b> Southern aspect is only half enclosed with a corrugated metal wall (Photo C). Some small gaps and crevices present where the metal sheets overlap on the wall (Photo D).</p> <p><b>Bat Roost Potential:</b> Low.</p> <p><b>Key Results and Potential Roosting Sites:</b> No evidence of bats found at the time of the survey.</p>

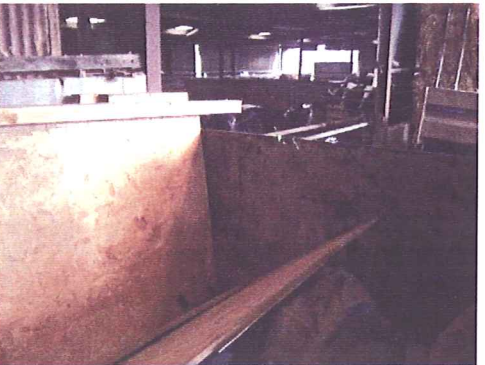
<p><b>Photo E:</b></p>

<p><b>Description:</b> Interior of building (Photo E) has several large access points, as the building currently house cattle and machinery. No roof voids and high light levels inside due to skylights and open sides. Metal joists.</p> <p><b>Bat Roost Potential:</b> None – no roosting features but potential foraging opportunities.</p> <p><b>Key Results and Potential Roosting Sites:</b> Single bat dropping found on surface within the interior.</p>
